**Horizontal Infrastructure Performance and Application
of the Liquefaction Resistance Index Methodology in
Christchurch City through the 2010-2011 Canterbury
Earthquake Sequence**

**Misko Cubrinovski
Matthew Hughes
Brendon Bradley
John Noonan
Steve McNeill
Geoff English
Irmana Garcia Sampedro**

September 2015

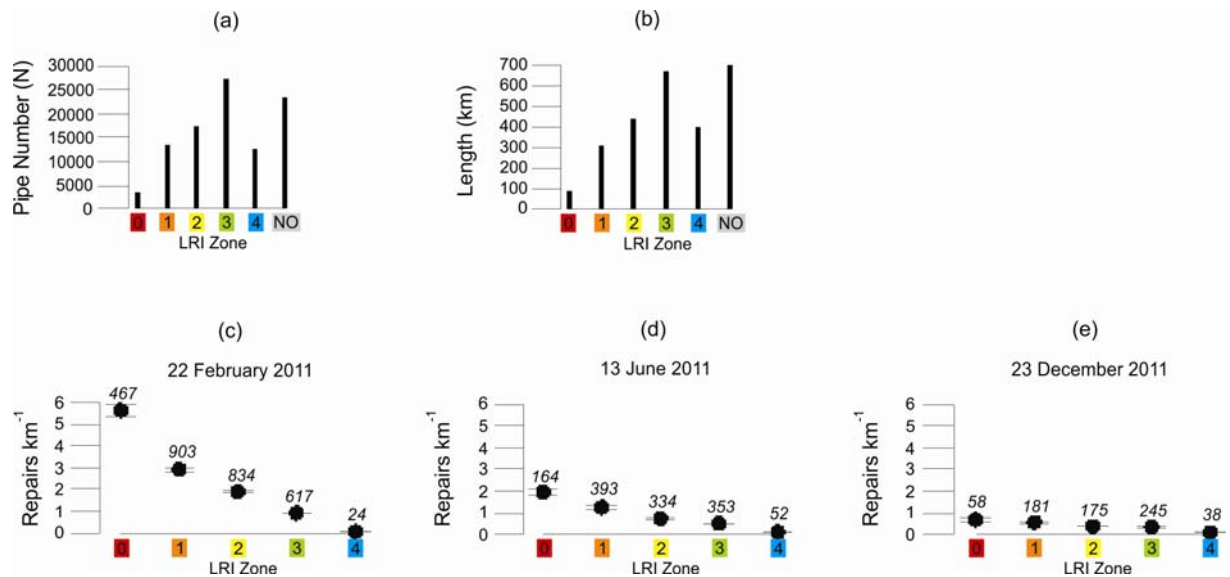
Figure 7 summarises the data for all pipe types. In order to understand the performance of different pipe types further analysis was conducted for the prevalent pipe materials for mains: Asbestos cement, Cast Iron, M-Polyvinyl chloride, Concrete-lined Steel, summarised in charts in Figure 8, and sub-mains: High-density Polyethylene, Medium-density Polyethylene, and Galvanised Iron pipes, summarised in Figure 9. In view of the fact that the February 2011 event was the most damaging and that records associated with the June 2011 and December 2011 earthquakes potential include damage caused by previous events and definitively include cumulative damage of the CES events, the repairs data associated with the February 2011 earthquakes is considered as the most reliable information (Figures 8c and 9c).

Figure 7. Potable water repairs for all major pipe types (Asbestos Cement, Cast Iron, M-Polyvinyl Chloride, Concrete-Lines Steel, High-Density Polyethylene, Medium-Density Polyethylene 80 and Galvanised Iron) in each Liquefaction Resistance Index (LRI) Zone. (a) Total number of pipes in each LRI zone, and areas of no liquefaction observations (NO). (b) Total pipe length (km) in each LRI zone, and areas of no liquefaction observations (NO). (c-e) Repair rates in each LRI zone and for the events of 22 February, 13 June and 23 December 2011, with standard errors indicated. Also shown are number of repairs (in *italics*) for each LRI zone.

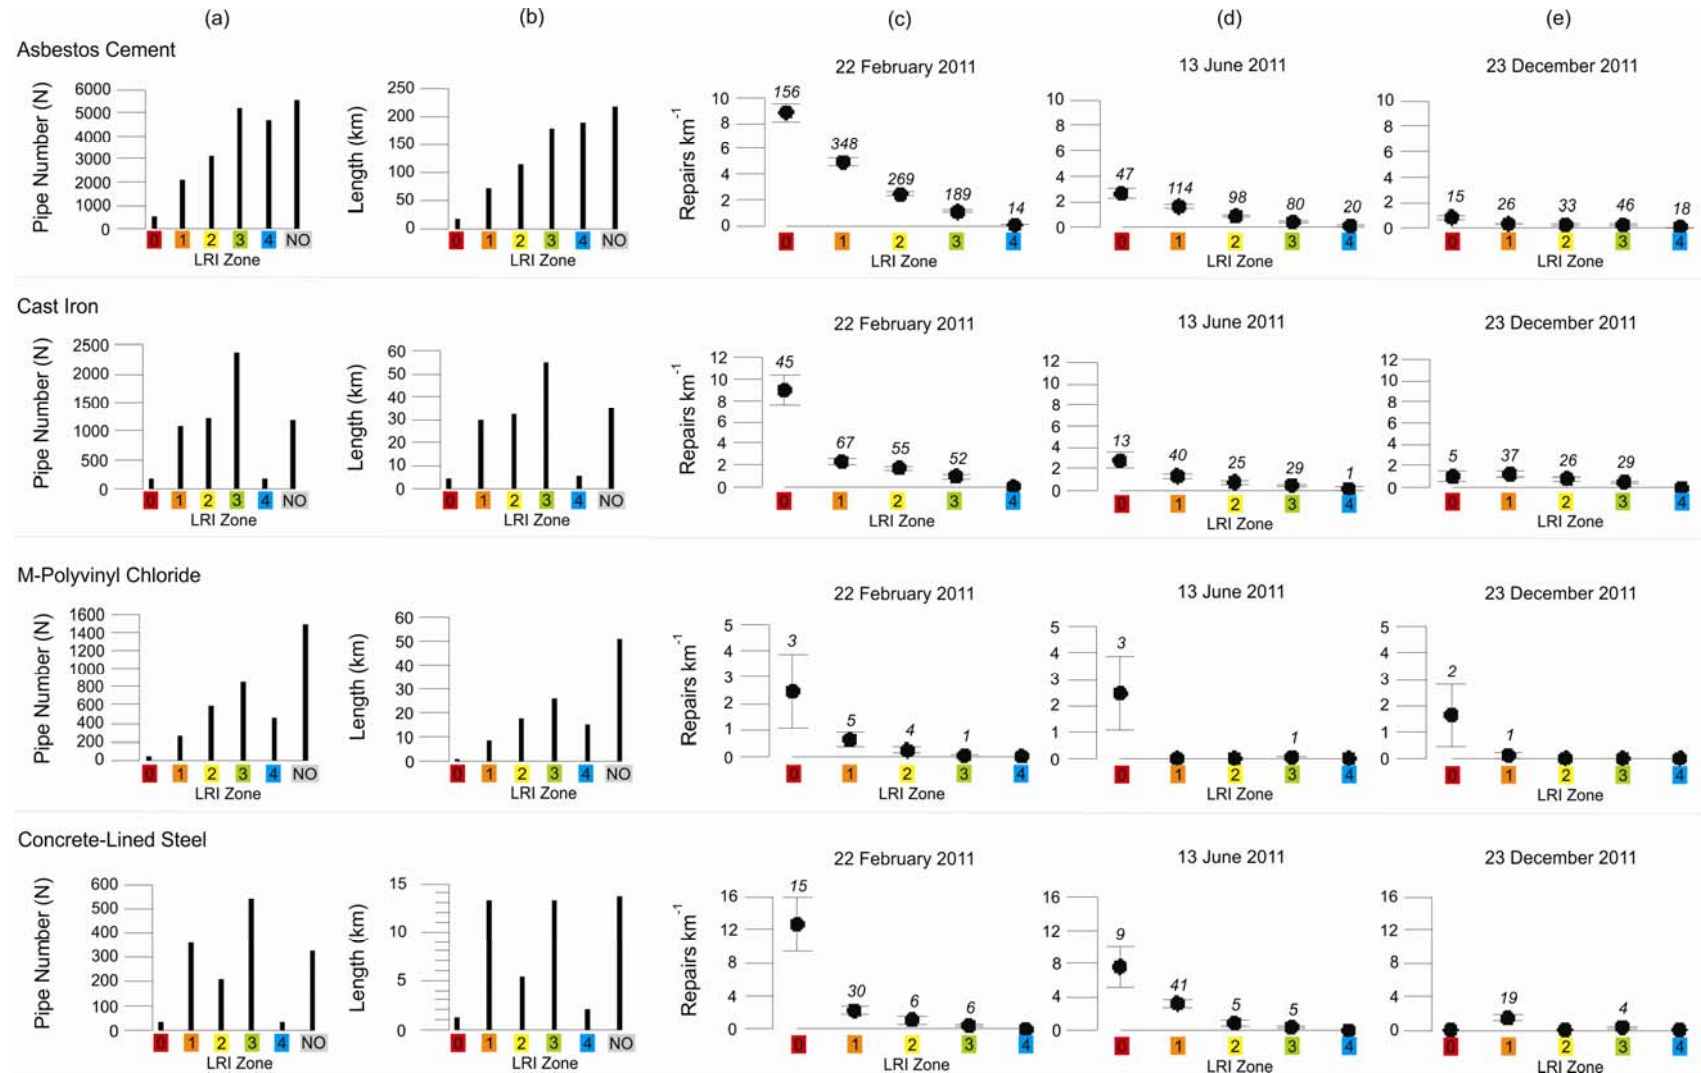
For the mains data, shown in Figure 8, the same trend is evident with the highest repair rates seen for the LRI Zone 0 and reduction in the rate of repairs with increase in the LRI Zone number. There is also a distinctive difference between the performance (repair rates) of brittle pipelines and ductile pipelines. For example, in LRI Zone 0, asbestos cement and cast iron have relatively high repair rates of about 9 per kilometre, concrete-lined steel and galvanized iron pipes have the highest repair rates of 12-19 per kilometre. On the other hand, the flexible pipelines (High-density Polyethylene, Medium-density Polyethylene, and M-Polyvinyl chloride) have much lower repair rates of 2-3 per kilometre. Importantly, the provided correlations provide basis for rigorous and detailed evaluation of the performance of different pipe materials or pipeline characteristics as a function of ground conditions and liquefaction resistance in particular. Note that LRI is directly related to a particular cyclic resistance or CRR as summarized in LRI, and hence, the analysis results derived in this study can be used to develop a predictive tool for evaluating the performance of potable water pipes of similar characteristics in future earthquakes affecting urban areas of New Zealand. It is important to note that other subtle but potentially important differences such as pipe diameters and connection details are subjects of further studies.

Figure 8. Potable water repairs for each Liquefaction Resistance Index (LRI) Zone and mains pipe materials. (a) Total number of pipes in each LRI zone, and areas of no liquefaction observations (NO). (b) Total pipe length (km) in each LRI zone, and areas of no liquefaction observations (NO). (c-e) Repair rates for each LRI zone and events of 22 February, 13 June and 23 December 2011, with standard errors indicated. Also shown are number of repairs (in *italics*) for each LRI zone.

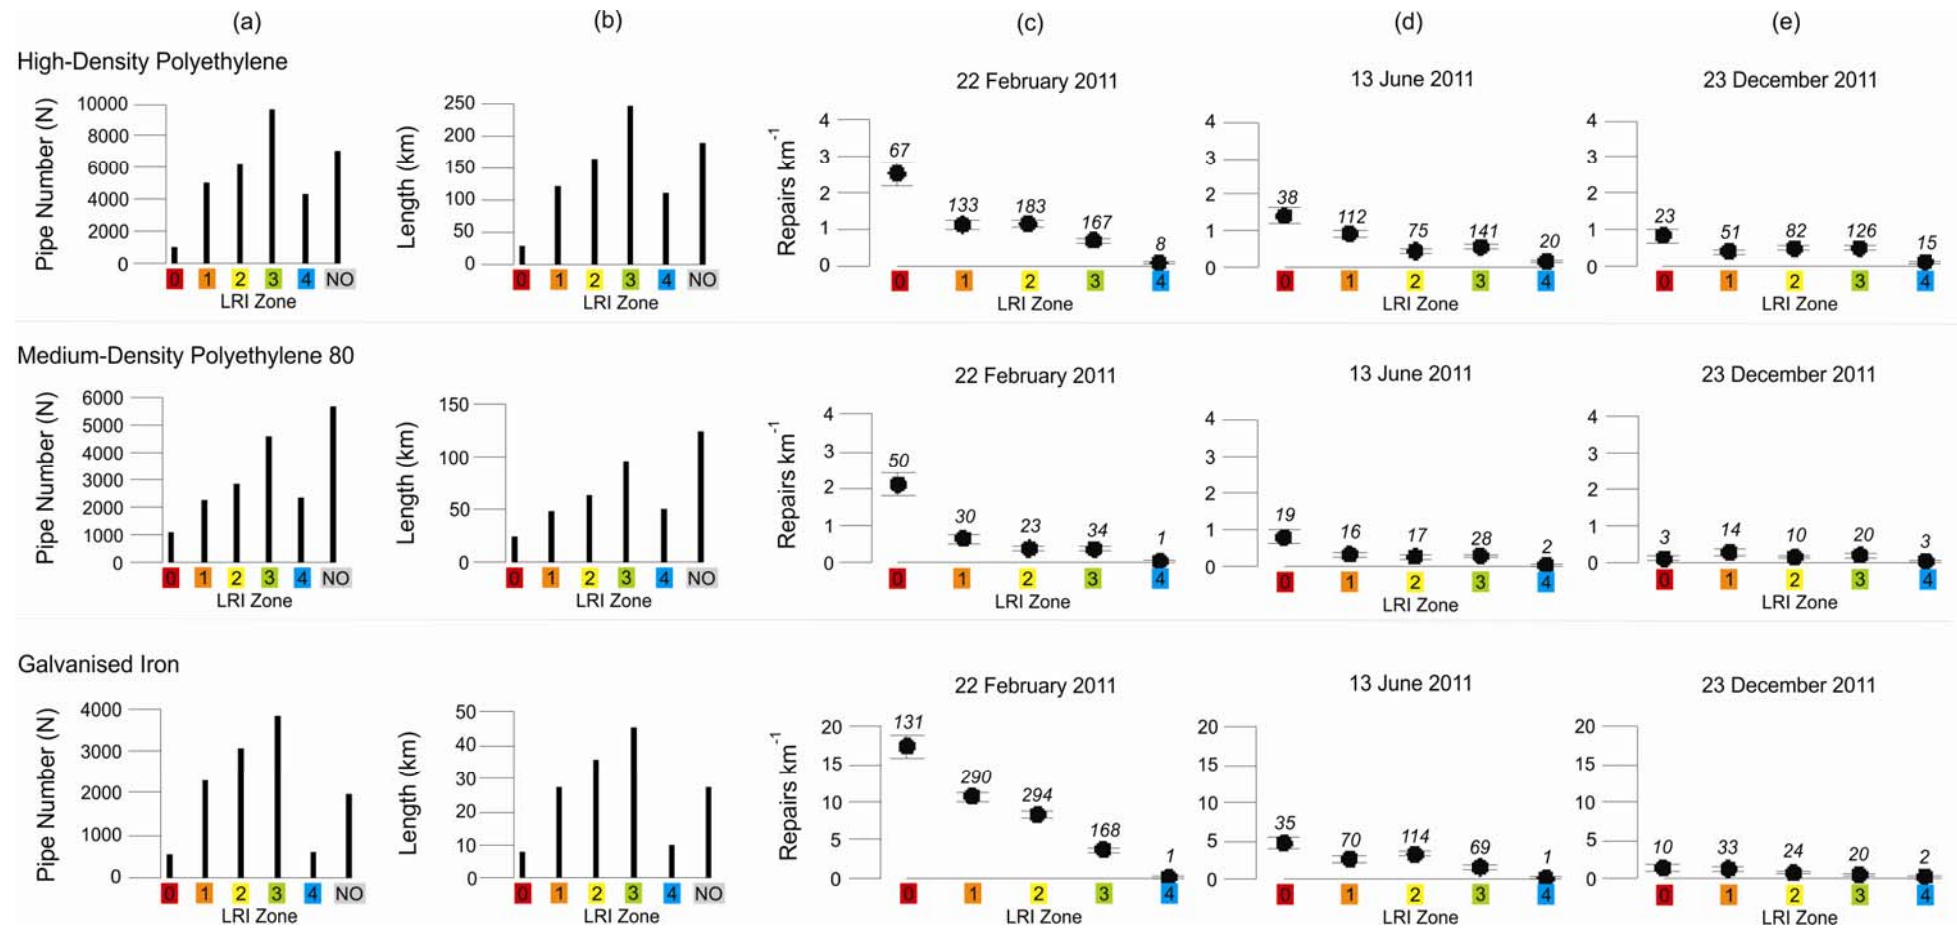
Figure 9. Potable water repairs for each Liquefaction Resistance Index (LRI) Zone and submain pipe materials. (a) Total number of pipes in each LRI zone, and areas of no liquefaction observations (NO). (b) Total pipe length (km) in each LRI zone, and areas of no liquefaction observations (NO). (c-e) Repair rates for each LRI zone and events of 22 February, 13 June and 23 December 2011, with standard errors indicated. Also shown are number of repairs (in *italics*) for each LRI zone.

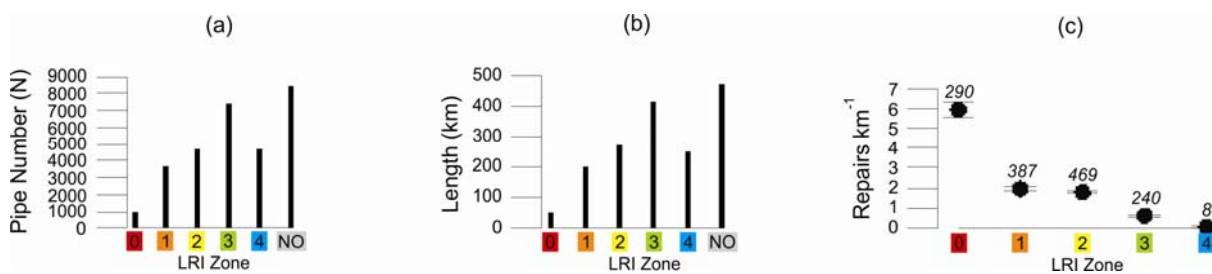
An equivalent analysis for the waste water pipes is presented in this section and summarised in Figures 10 and 11. Here no distinction is made between individual CES events, although most repairs appear to be in response to 22 February 2011 and to a lesser extent 13 June 2011 and 23 December 2011. Again, there is a clear trend in the repairs rate as a function of the LRI Zone number or liquefaction resistance of soils. LRI Zone 0 is characterized by about 6 repairs per kilometre, which is 10 times higher than the repairs rate of LRI Zone 3 and nearly 200 times the repairs rate of LRI Zone 4.

Figure 10. Waste water repairs for all major pipe types (Asbestos Cement, Cast Iron, M-Polyvinyl Chloride, Concrete-Lines Steel, High-Density Polyethylene, Medium-Density Polyethylene 80 and Galvanised Iron) in each Liquefaction Resistance Index (LRI) Zone. (a) Total number of pipes in each LRI zone, and areas of no liquefaction observations (NO). (b) Total pipe length (km) in each LRI zone, and areas of no liquefaction observations (NO). (c) Repair rates for each LRI zone, with standard errors indicated. Also shown are number of repairs (in *italics*) for each LRI zone.

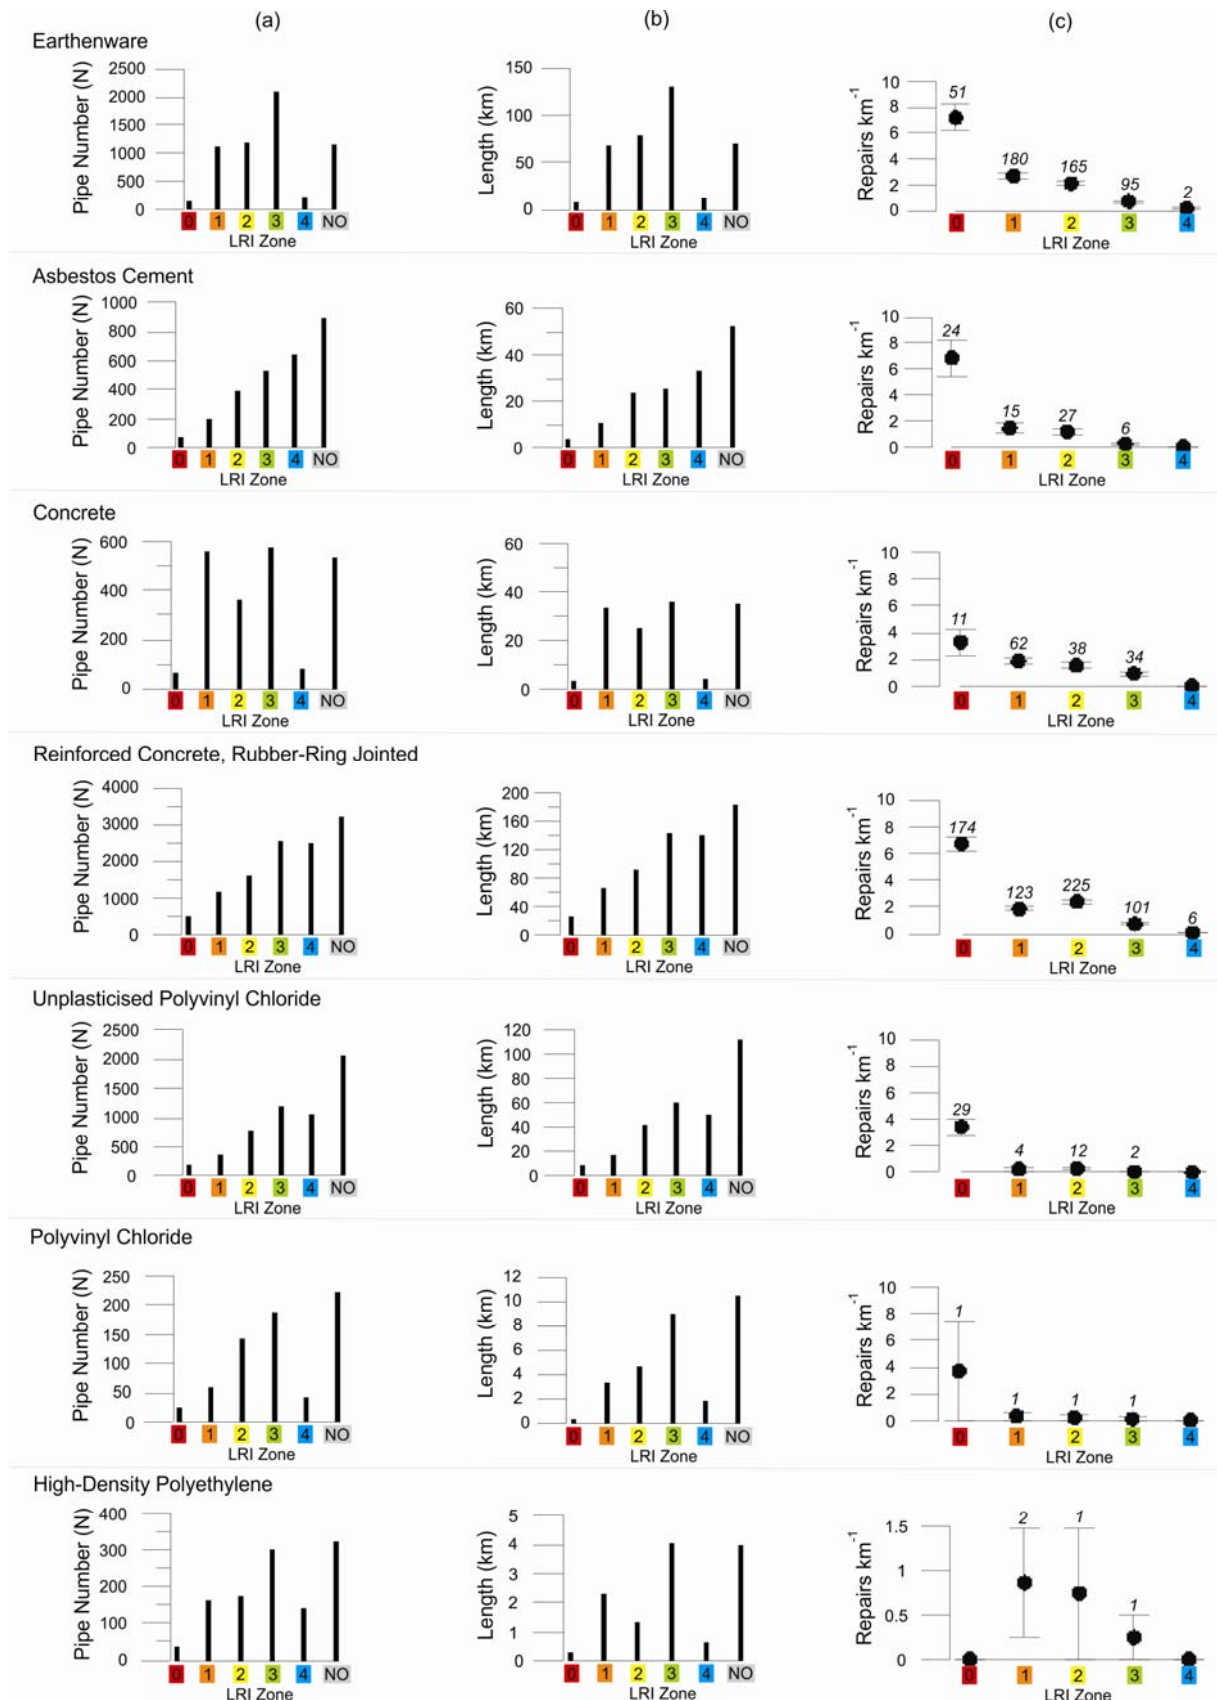
Consistent with the potable water pipes performance, more ductile materials and flexible pipelines of the waste water network, such as PVC pipes, performed reasonably well showing low and tolerable repair rates across LRI Zones 1 to 4. Conversely, brittle material pipes and less flexible waste water pipelines of earthenware, asbestos cement, concrete, and reinforced concrete rubber-ring jointed show much higher repair rates particularly in zones of lower liquefaction resistance (LRI Zones 0, 1 and 2). Note that some of the results for PVC and polyethylene pipes are based on small number of pipes and hence the associated errors are significant and the evidence is inconclusive due to these limitations of the subset.

Figure 11. Wastewater repairs for each Liquefaction Resistance Index (LRI) Zone and pipe materials. (a) Total number of pipes in each LRI zone, and areas of no liquefaction observations (NO). (b) Total pipe length (km) in each LRI zone, and areas of no liquefaction observations (NO). (c) Repair rates for each LRI zone, with standard errors indicated. Also shown are number of repairs (in *italics*) for each LRI zone.

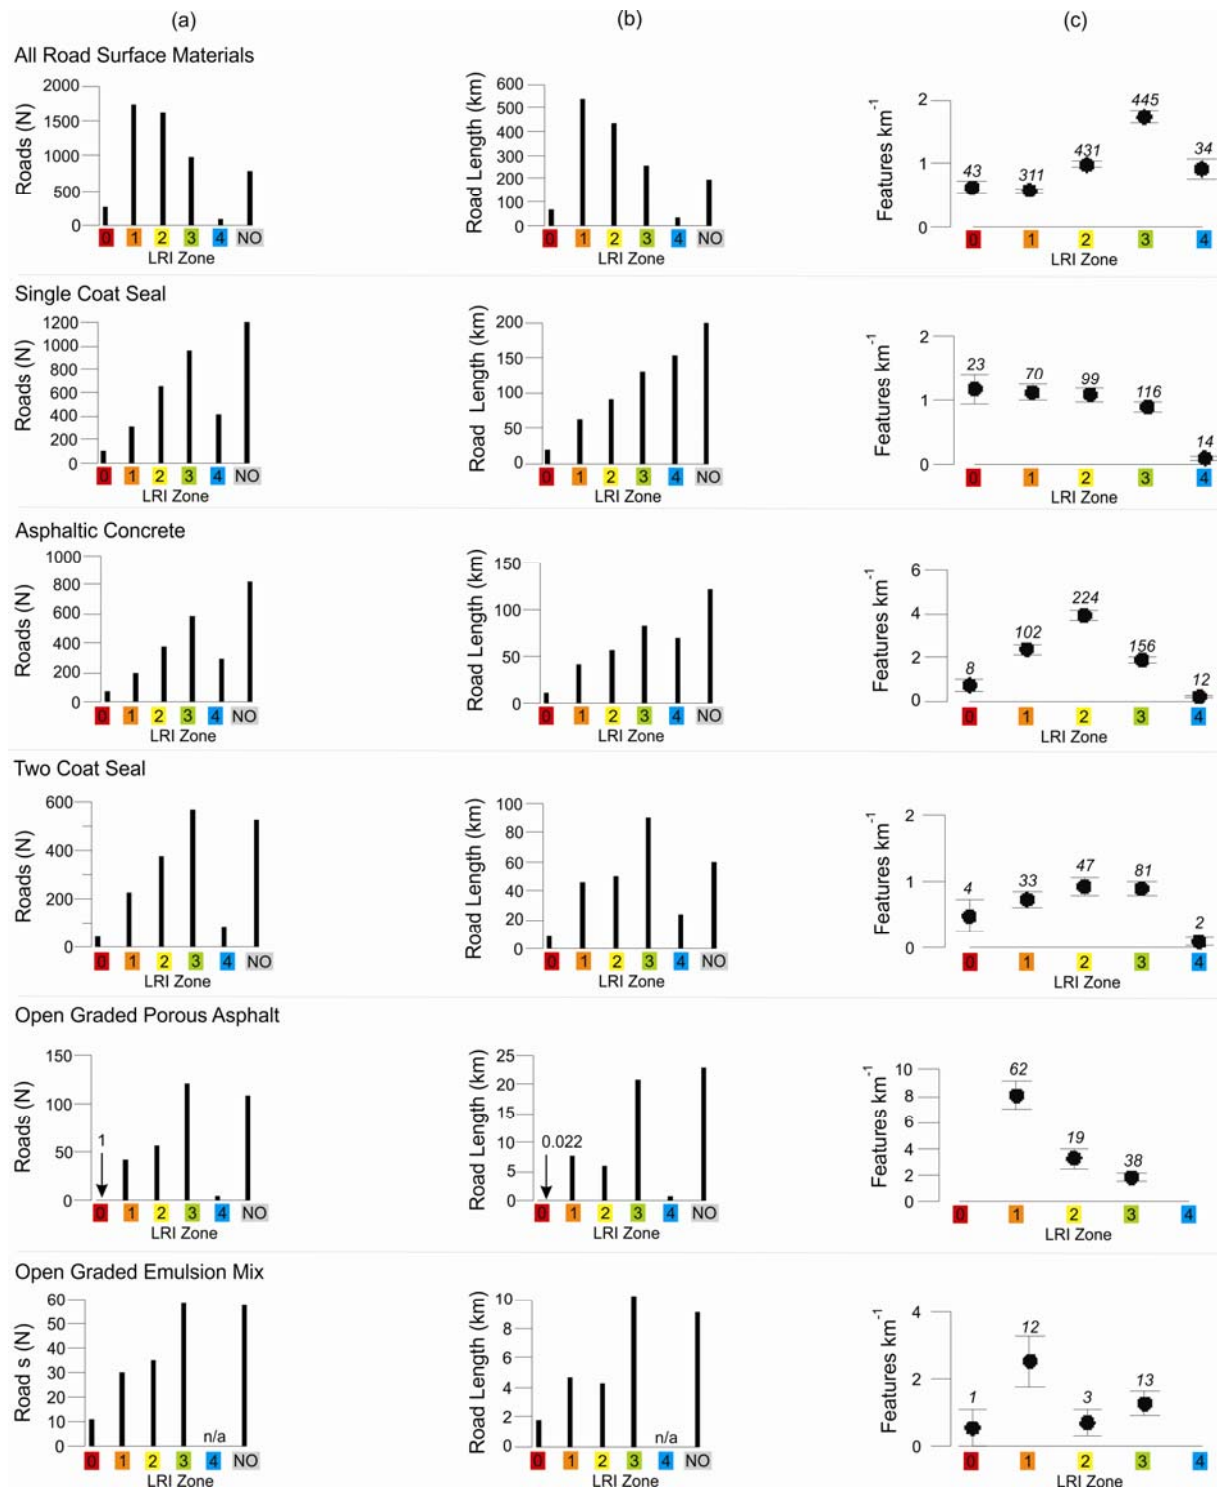
The damage to the road network of Christchurch was evaluated in the same manner as the pipe networks of the potable and waste water systems. For the road network three damage indicators were used: road 'failures' (cracks, fissures and vertical offsets), undulations resulting in uneven road surface, and uneven settlement or subsidence resulting in ponding of the roads. The summary analyses in terms of rates of failures, occurrences of uneven surfaces or ponding plotted against the LRI Zone are shown in Figures 12, 13 and 14.

Note that in many cases the data for the LRI Zone 0 is not representative for the performance of roads in this zone because majority of this zone was declared a Red Residential Zone and hence was outside the scope of damage evaluation and repairs. Having this potential anomaly in mind, by and large, the three datasets show consistent trend of increase in rates of damage features with a decrease in the liquefaction resistance of soils (or decrease in the LRI Zone number).

Figure 12. Road pavement damage observations (fissures, cracks, vertical offsets and potholes) across LRI zones. (a) Total number of roads in each LRI zone, and areas of no liquefaction observations (NO). (b) Total road length (km) in each LRI zone, and areas of no liquefaction observations (NO). (d) Rate of mapped features for each LRI zone, with standard errors indicated. Also shown are number of mapped features (in *italics*) for each LRI zone.

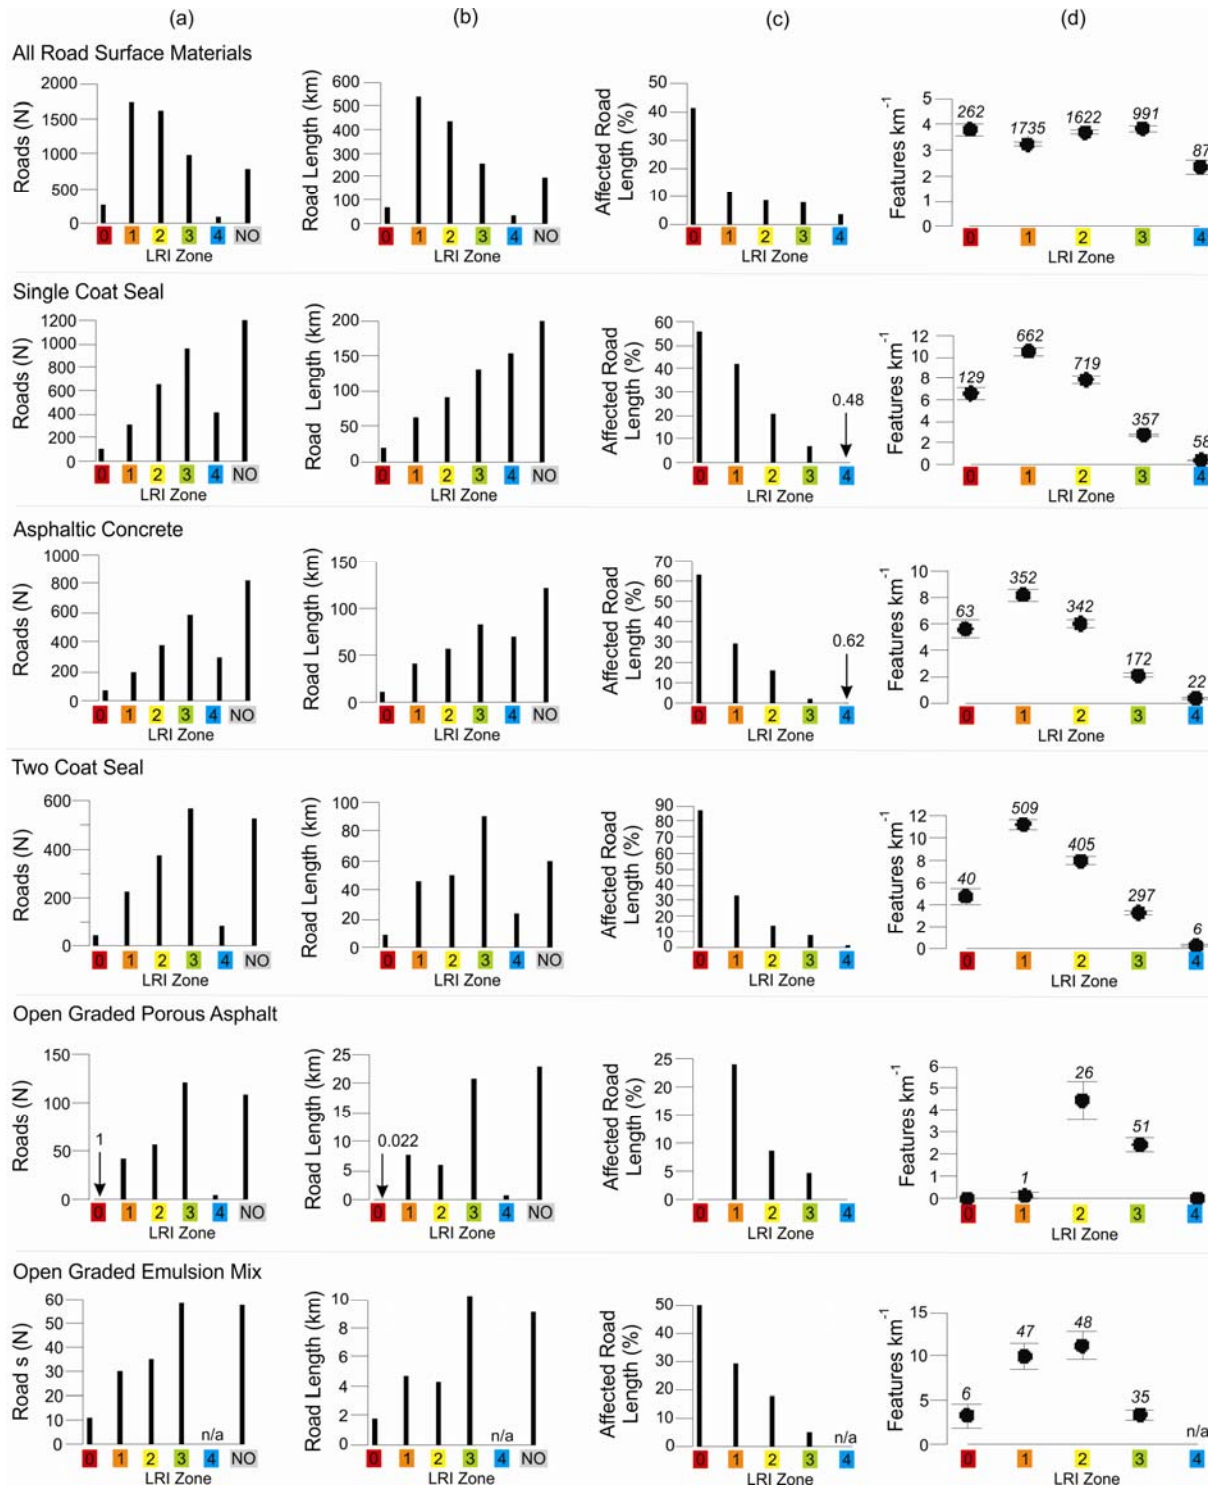
Figure 13. Road damage classified *uneven surface* for each Liquefaction Resistance Index (LRI) Zone and road surface material. (a) Total number of roads in each LRI zone, and areas of no liquefaction observations (NO). (b) Total road length (km) in each LRI zone, and areas of no liquefaction observations (NO). (c) Percentage of road length affected, classified as *uneven surface*, for each LRI Zone. (d) Rate of mapped features classified as *uneven surface* for each LRI zone, with standard errors indicated. Also shown are number of mapped features (in *italics*) for each LRI zone.

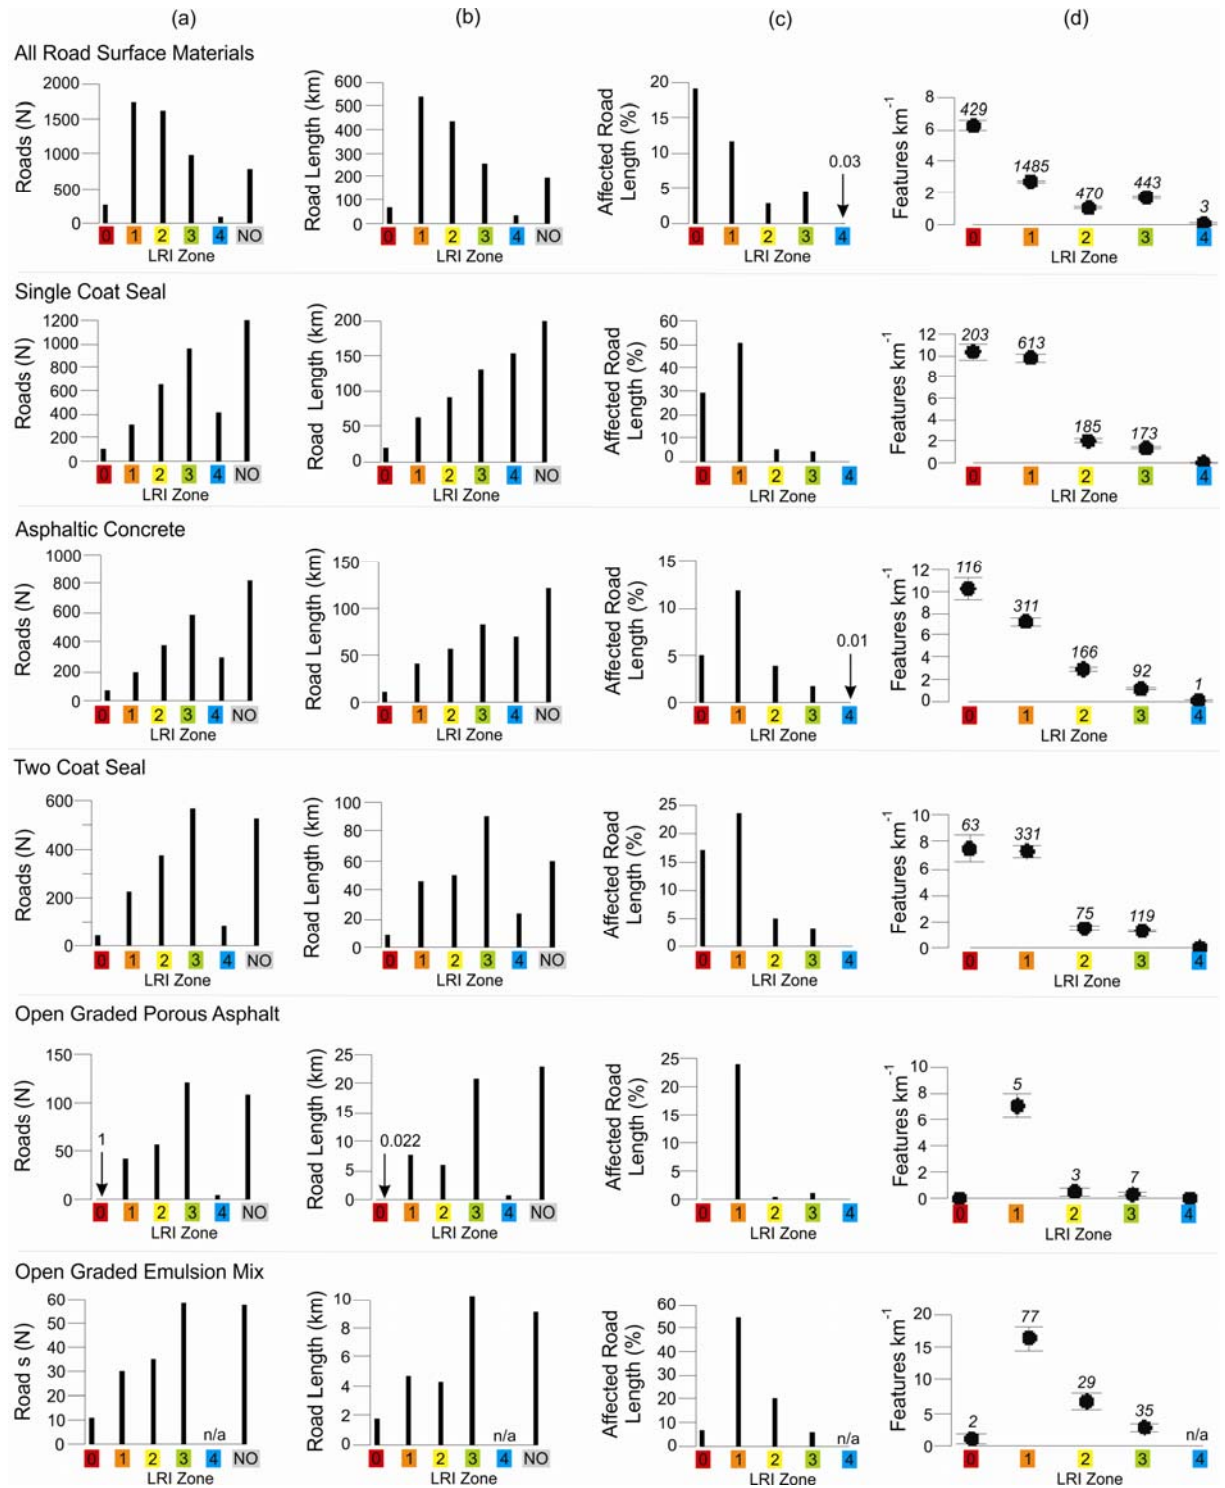
Figure 14. Road damage classified *ponding* for each Liquefaction Resistance Index (LRI) Zone and road surface material. (a) Total number of roads in each LRI zone, and areas of no liquefaction observations (NO). (b) Total road length (km) in each LRI zone, and areas of no liquefaction observations (NO). (c) Percentage of road length affected, classified as *ponding*, for each LRI zone. (d) Rate of mapped features classified and *ponding* for each LRI zone, with standard errors indicated. Also shown are number of mapped features (*in italics*) for each LRI zone.

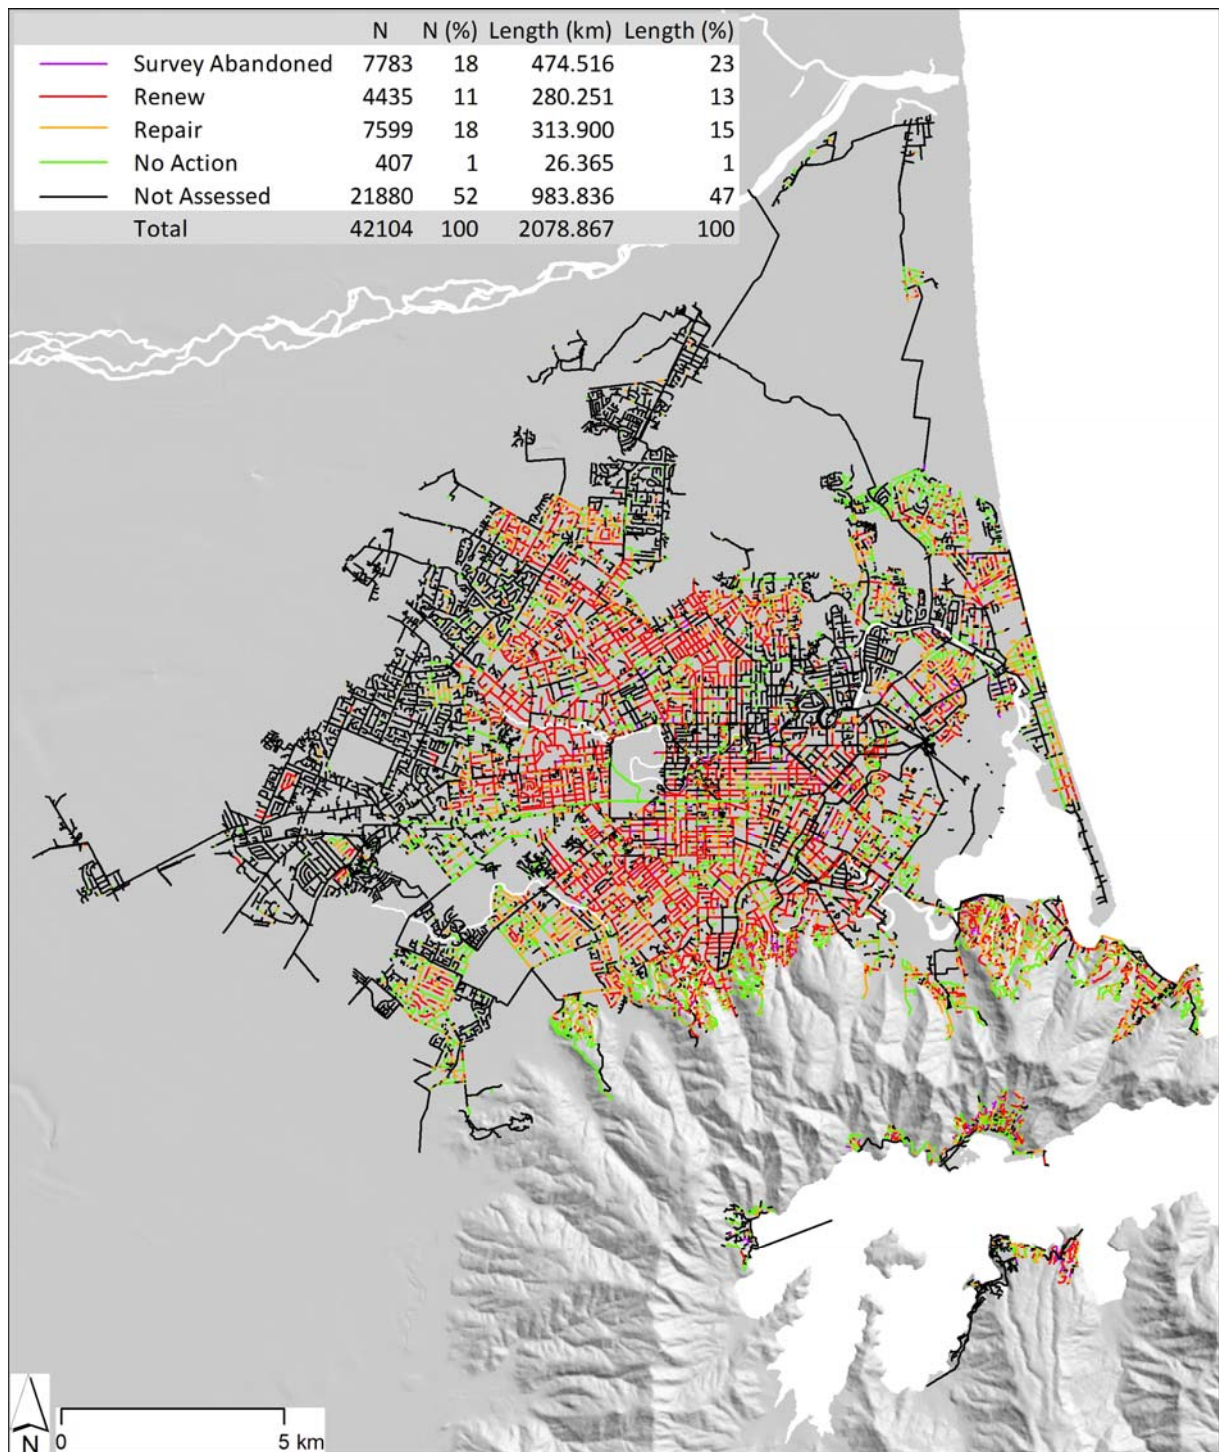
Based on specific criteria (SCIRT 2012; 2013), CCTV damage observations were classified by SCIRT into actions to be undertaken: renew (replacement of the entire pipe), repair (sections of a damaged pipe patched or replaced) or no action (Figure 18). A significant percentage of observations were abandoned, indicating that the CCTV survey had to be discontinued due to obstructions or pipe damage, both of which can often be attributed to earthquake effects. A large portion of the Residential Red Zone along the Avon River was unsurveyed, as this area was deemed unviable for future residential land use, and CCTV analyses were unnecessary. Final decisions on courses of action for specific pipes or groups of connected pipes were ultimately the responsibility of SCIRT design teams, who also incorporated profilometer and other site-specific information. While the CCTV data were not necessarily the final determinant of reinstatement actions, these data, supplemented by profilometer information, provide the most accurate assessment of pipe performance and physical damage in response to transient and permanent ground deformation. Fifty-four percent of Christchurch's waste water network has been assessed by either or both CCTV and profilometer, providing a picture of post-earthquake infrastructure performance unprecedented in detail.

Figure 18. Assessment of actions (renew, repair, no action) for waste water pipes based on CCTV analysis. Survey Abandoned denotes CCTV surveys unable to be completed in the field due to pipe obstruction/damage.

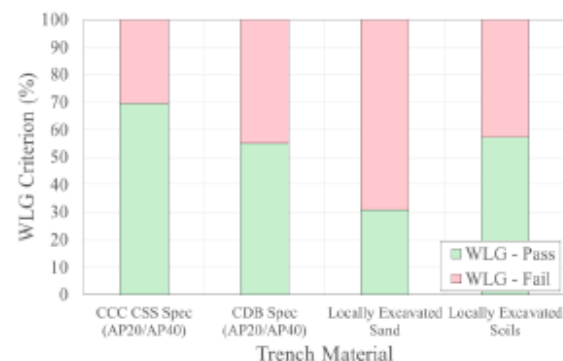
While the abovementioned is coherent across all trench materials, special consideration should be given to the fact the distribution of trench material data is unevenly distributed across the 103 pipes that have been selected. As a result it should be acknowledged that these results are potentially biased.

Figure 4. Performance of trench materials to the Whole Length Gradient criterion.

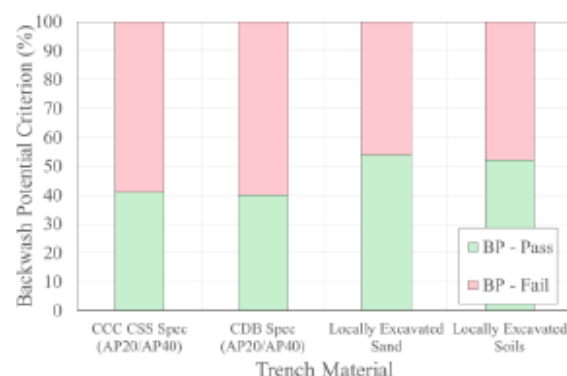
Figure 5. Performance of trench materials to the Backwash Potential criterion.

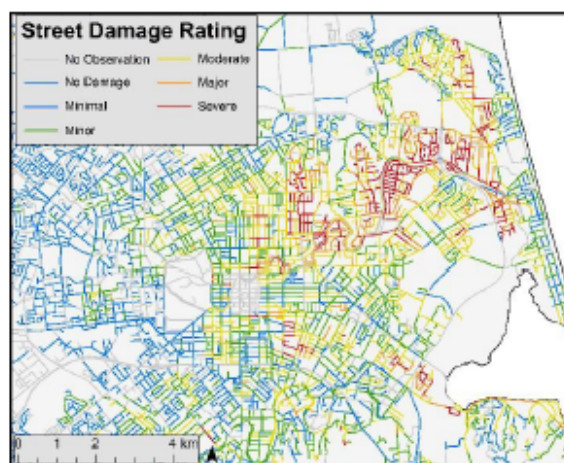
Should road damage exceed 75% of its renewal cost, the CCC made the decision to renew the entire road. This decision reflected the small amount of additional cost that would be required to replace the road instead of completing repairs. For the purposes of this project, it was decided to merge the no damage and minimal damage ratings. This was because the difference between 0% and 1% damage was considered to be too small to justify a standalone category. The street damage map is shown in Figure 3.

Figure 3. Street damage rating showing combined colour of no damage and minimal ratings

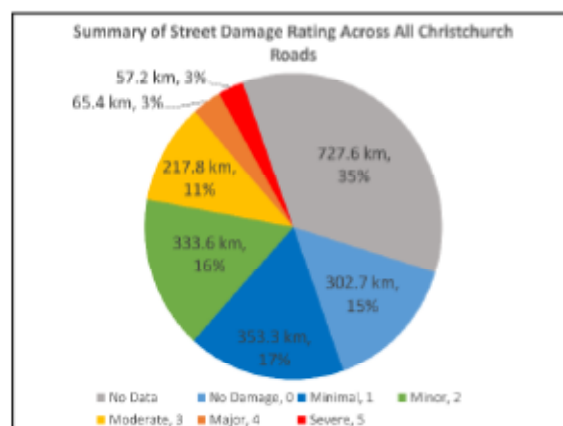
after the February 2011 earthquake. This reflects the concentration of road damage within the urban reaches of the city.

Figure 5. Summary of street damage rating across the Christchurch road network after the 22 February 2011 earthquake (total 2058 km)

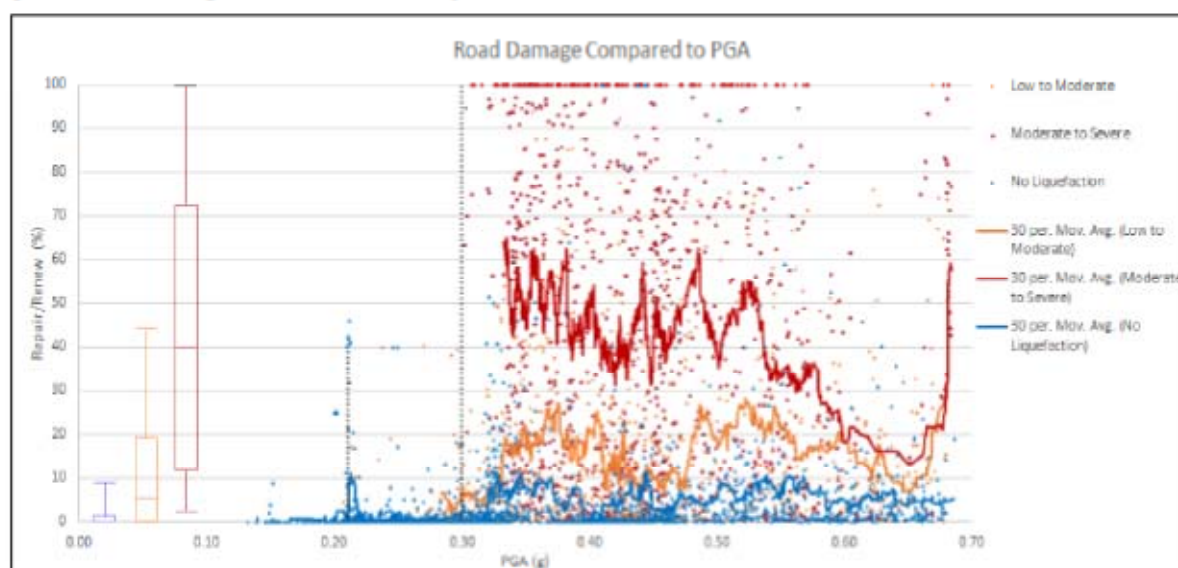
The relationship between PGA and road damage was not immediately clear. Black dotted lines on Figure 6 show apparent threshold values of PGA. The first threshold

Figure 6. Comparison of percentage of street damage to PGA, isolating liquefaction observation categories.

was at a PGA of approximately 0.2g. Below 0.2g, road damage did not exceed 10% and averaged just 0.3%.

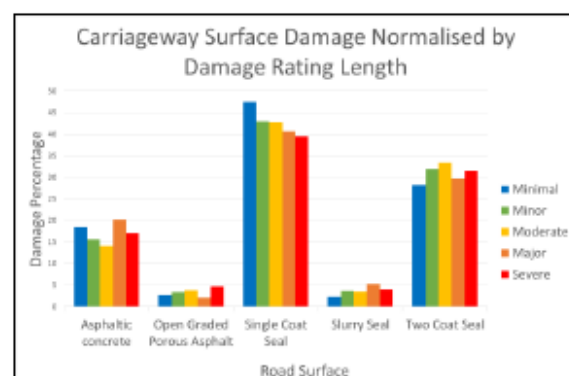
Figure 7 shows the most predominant carriageway surface types compared to sustained damage. To enable easier identification of trends, the data has been normalised, ensuring the damage category adds to 100% across every road surface type. This removes distorting effects such as the existence of more data points in the minimal damage category compared to the severe category. Figure 7 therefore shows which road surface types are most common, indicated by the larger datasets.

Figure 7. Performance of predominant carriageway surfaces.
